INTERIM REPORT M-336
November 1983

**CONSTRUCTION OF ALUMINUM STANDING-SEAM
ROOFING AT AN ARMY FACILITY**

by
Myer J. Rosenfield

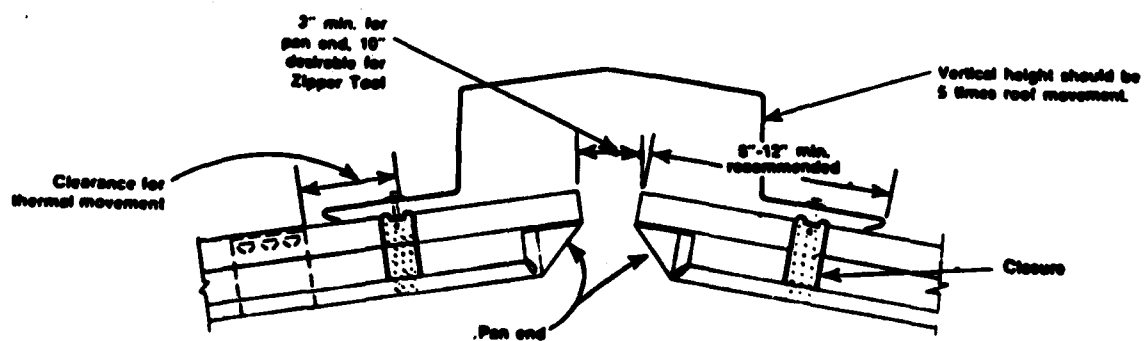
All this careful attention to detail, fabrication, and installation yields a roofing system which should provide many years of satisfactory service. The only deficiencies noted were related to design and installation of the ridge cap. On Warehouse 8, these occurred where the ridge cap intersected the flashings at the large central vents, and also occurs on all warehouses where the ridge caps ended at the firewall parapets.

Figure 12. Ridge cap and end closures.

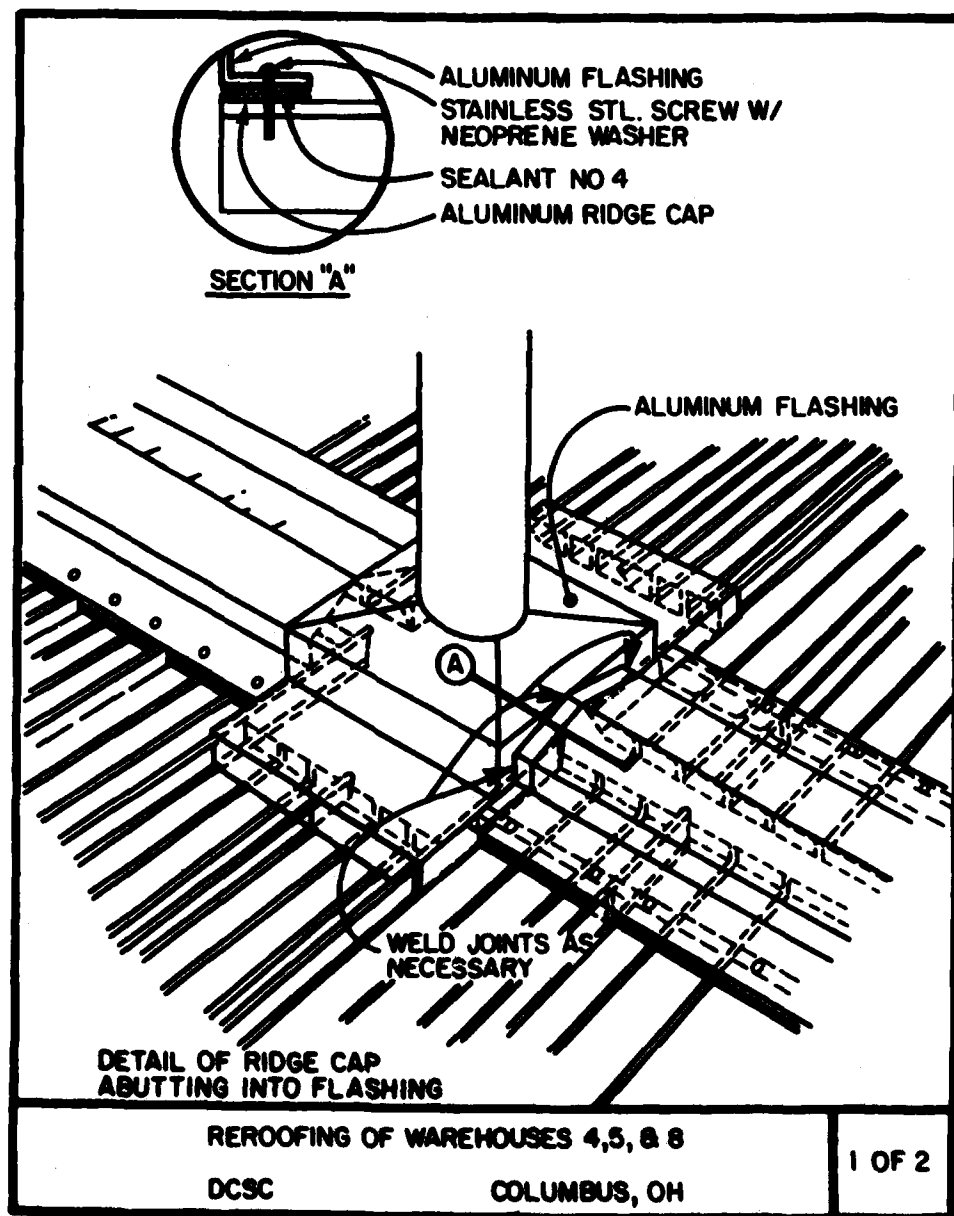
The ventilator flashing intersection was detailed on the drawing shown in Figure 17. This shows a 5-in. (127-mm) vertical wall of the flashing, with the ridge cap low enough for the connection to be completely within this dimension. As shown in Figure 12, the vertical height of the ridge cap should be at least five times the expected roof movement. For 40 ft (12 m) of aluminum over a temperature range of -20°F (-29°C) to 120°F (49°C)—a difference of 140°F (78°C)—the expected change in length is about 7/8 in. (22 mm). Following the recommendation of Figure 12, the vertical height was set at 6 in. (152 mm). To fabricate the intersection as shown in Figure 18, the height of the vent flashing would have to be increased to more than the ridge cap. Instead, it was made equal to the ridge cap wall, and was actually fabricated to the 6-in. (152-mm) dimension. This made the intersection impossible to fabricate as detailed; the result is shown in Figure 19. A large amount of sealant was needed to waterproof these intersections.

Figure 18. Detail of ridge cap at ventilator flashing.

Since these two ridge cap details depend greatly on the sealant to keep them watertight, they will have to be monitored very carefully to be sure that any deterioration of the sealant is repaired quickly and thoroughly.
